Essex County  
Fire & Rescue Service

# **RAAC Reinforced autoclaved aerated concrete**

**29<sup>th</sup> September 2023**

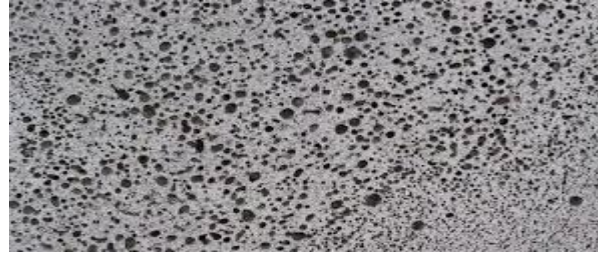
The aerated texture of RAAC plank. This is the same as a 'Breeze block' and the same manufacturers typically made RAAC as lightweight aerated concrete block work, such as Durox, Celcon and other manufacturers.

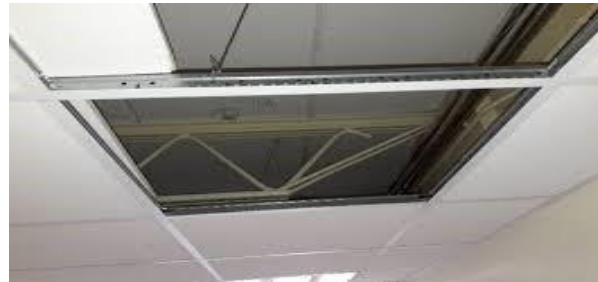
Appearance of RAAC 0.6m wide planks above suspended ceiling. Note Castellated Beam at mid-span.

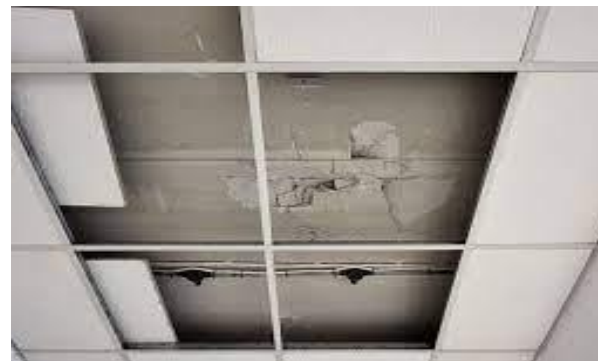
RAAC planks at advanced levels of deflection with spalled aerated concrete from steel reinforcement which are in danger of collapse.

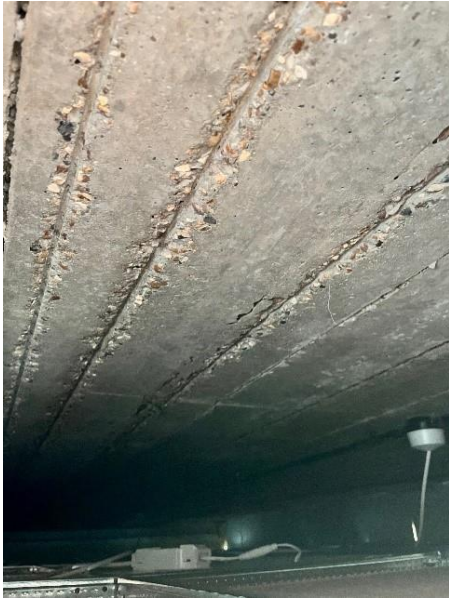
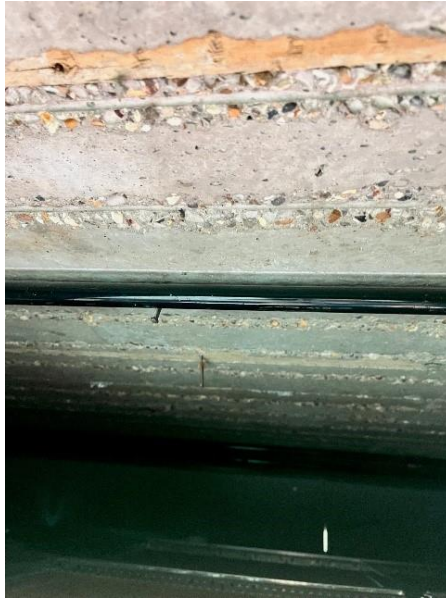
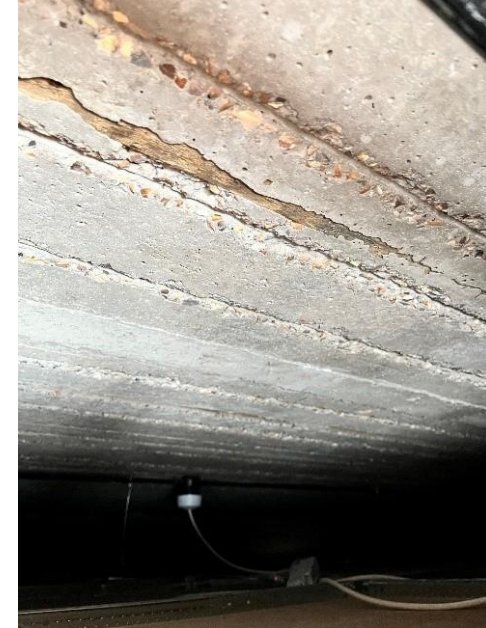
## **Great Baddow Fire Station.**

The roof to all areas of the building accessible were found to be of reinforced cast concrete. No RAAC was detected.

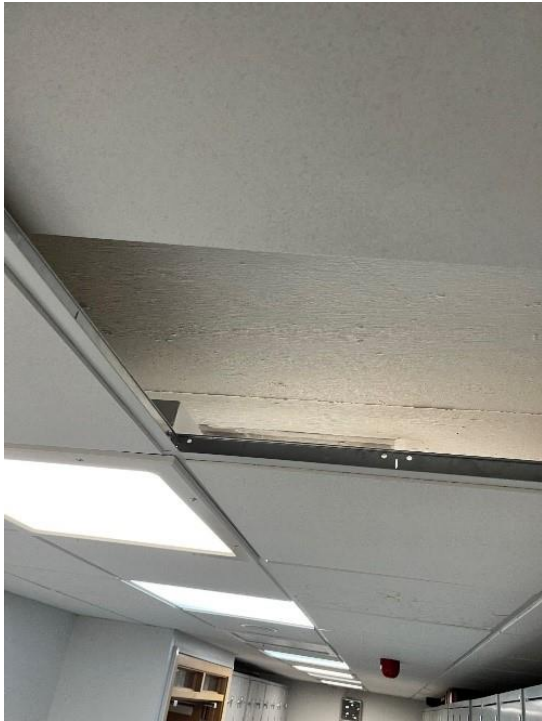
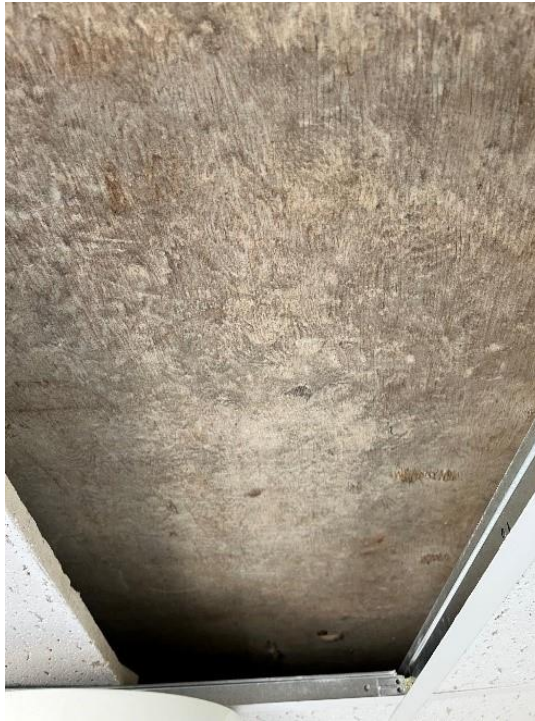
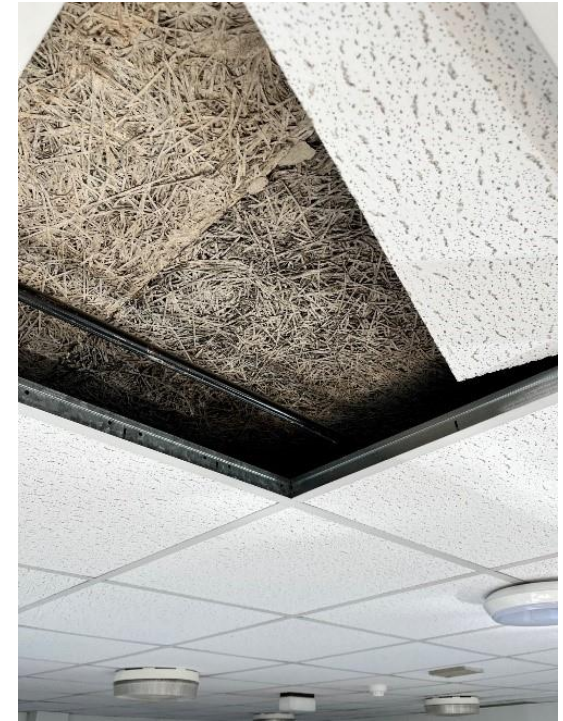
### **Leigh-on-Sea Fire Station.**

The Main Fire Station roof comprises reinforced cast concrete. The Appliance Bay and 1<sup>st</sup> floor roof is formed of 'Woodwool' slabs on castellated beams. No RAAC was detected.

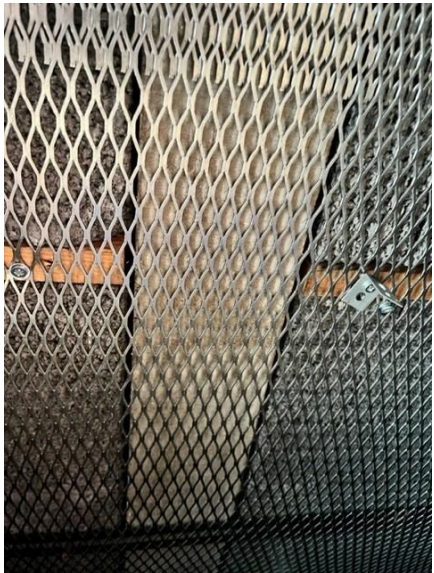
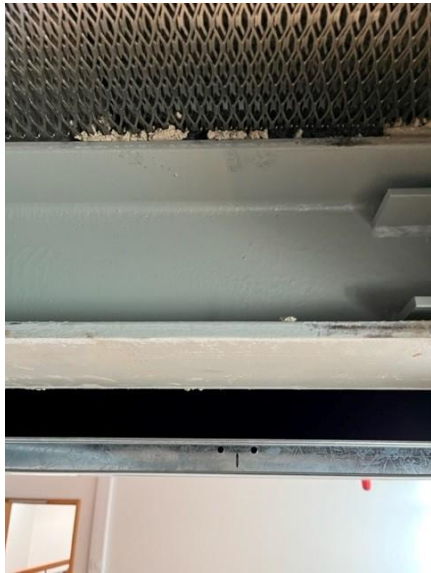
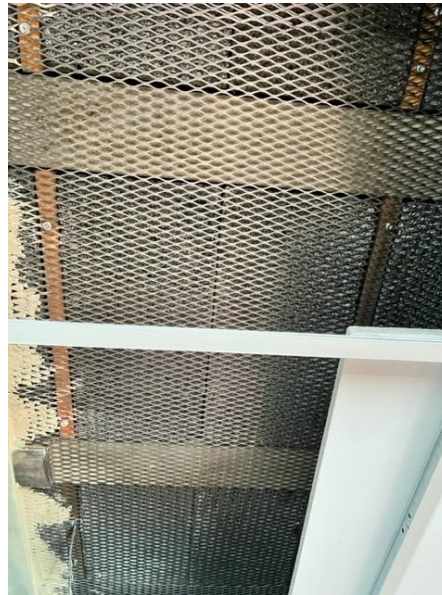
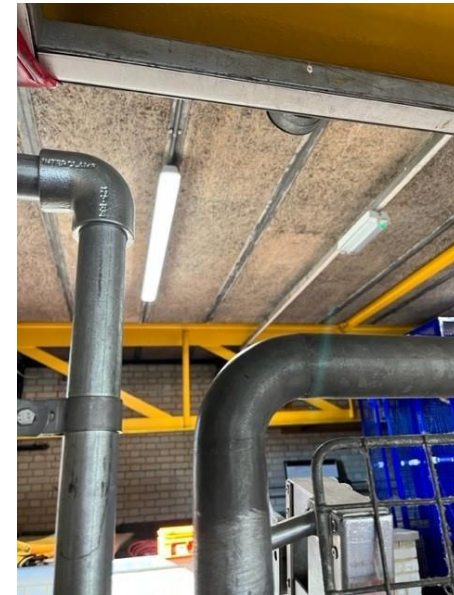
## **Witham Fire Station and STC.**

The roof to the main Fire Station where accessible for inspection comprises Pre-Cast reinforced Concrete Beams with block infill. The presence of expanded metal lathes and steel beams show that roof strengthening works have already been carried out, this was undertaken circa. 2016 as evidenced by Structural Engineers Reports as prepared by Messrs. Ingleton Wood. The STC roof comprises Woodwool slabs on castellated beams. No RAAC was detected.

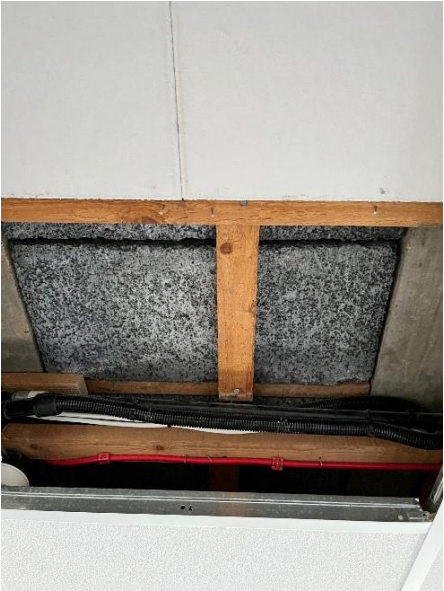
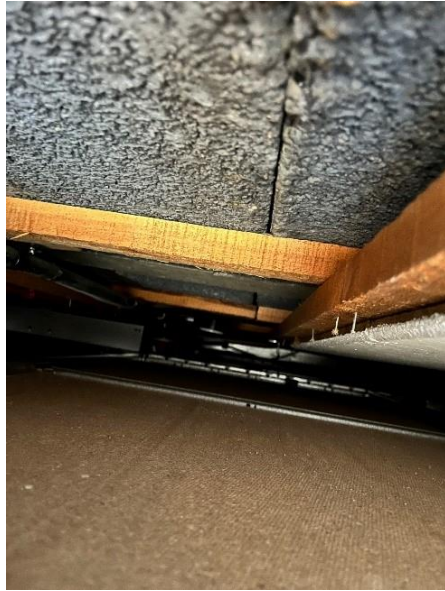
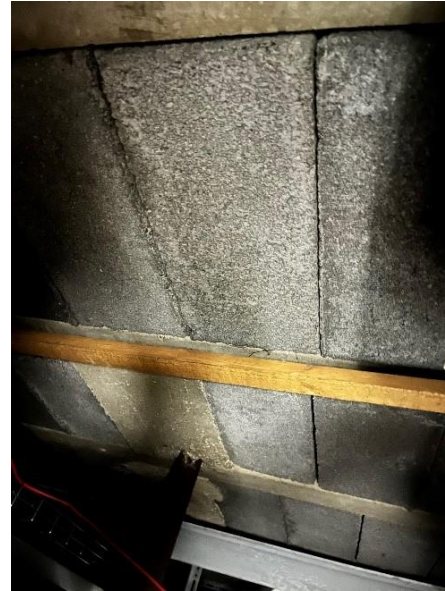
## **Dovercourt Fire Station.**

All areas of ceiling accessible showed the roof is formed on reinforced concrete beams with block infill. Unlike Loughton and Witham Fire Stations there was no evidence of any roof strengthening works, and I would recommend a detailed survey be carried out in early course by a suitably qualified Structural Engineer to check for deflection, loading, bearings and spans. No RAAC was detected.

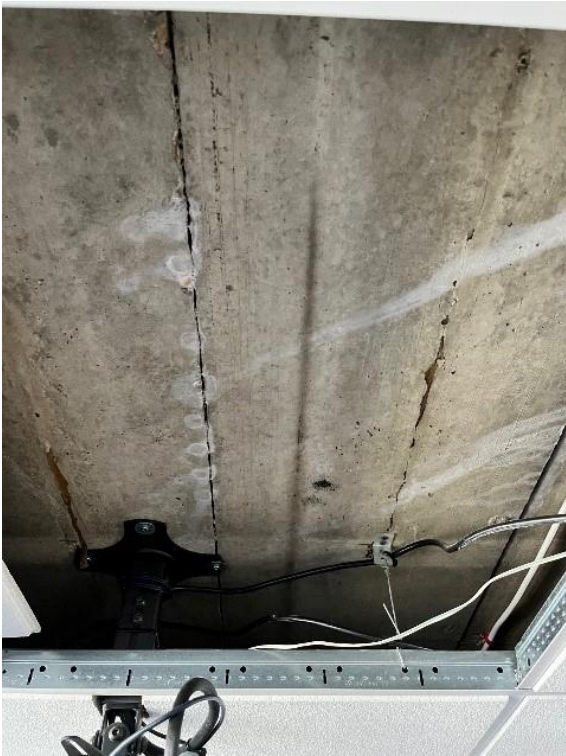
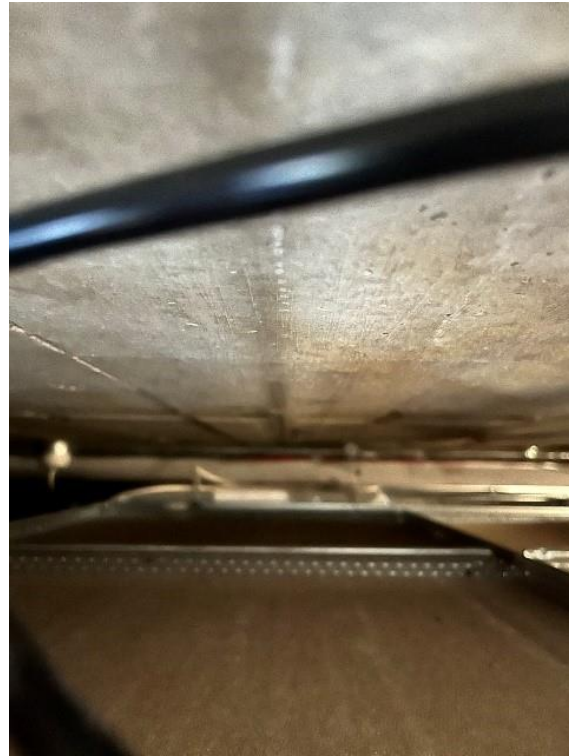
### **Waltham Abbey.**

The roof is formed of reinforced cast concrete to all areas accessible for inspection. No RAAC was detected.

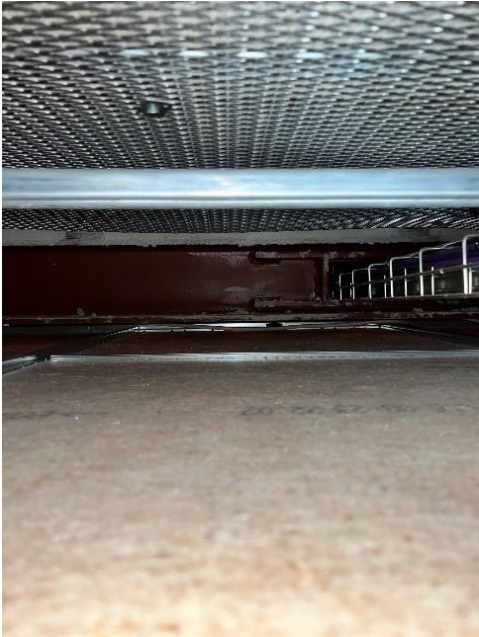
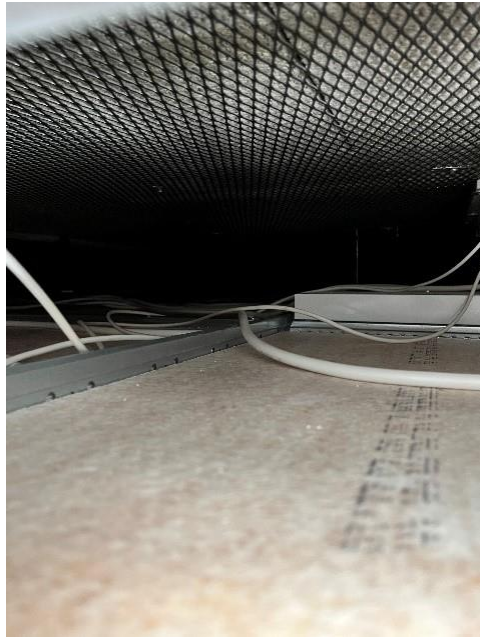
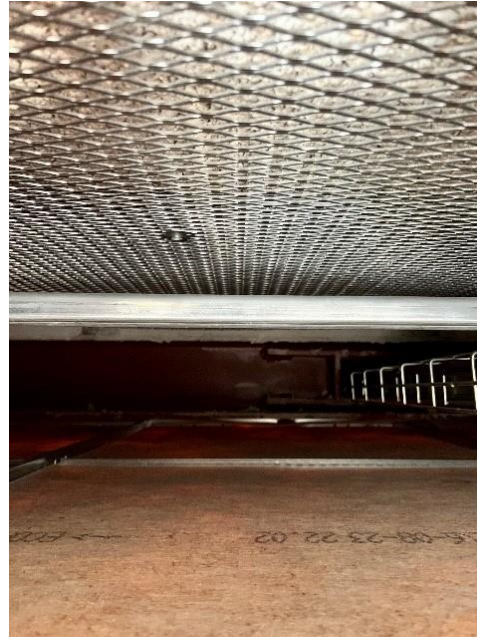
## **Loughton Fire Station.**

The roof to the Fire Station where accessible for inspection comprises Pre-Cast reinforced Concrete Beams with block infill. The presence of expanded metal lathes and steel beams show that roof strengthening works have already been carried out, this was undertaken circa. 2016 as evidenced by Structural Engineers Reports as prepared by Messrs. Ingleton Wood. No RAAC was detected.
